**UNDERWATER SOUND LEVELS
ASSOCIATED WITH PILE DRIVING AT
THE CAPE DISAPPOINTMENT BOAT
LAUNCH FACILITY, WAVE BARRIER
PROJECT**

*Prepared by:
Jim Laughlin
Washington State Department of
Transportation
Office of Air Quality and Noise
15700 Dayton Avenue North,
P.O. Box 330310
Seattle, WA 98133-9710*

March 2006

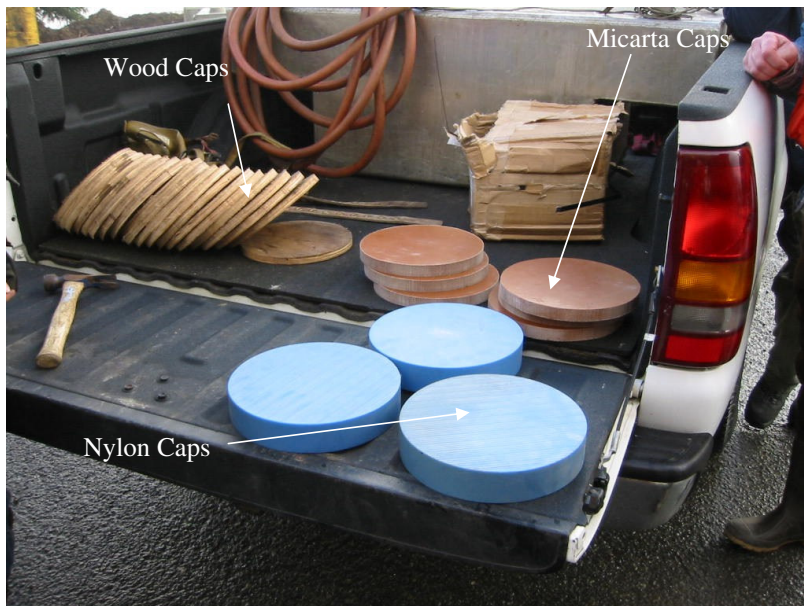
Figure 1: Pile cap types tested in this monitoring project (Conbest pile cap not shown).

Piles were driven using different pile cap materials and monitored to look for differences (in sound pressure?). The pile cap materials tested were wood (plywood), Conbest, Micarta, and Nylon. Piles were driven with an air hammer. Table 1 summarizes the results for each pile monitored. The bubble curtain was tested with the bubbles off and then on during the pile driving events.

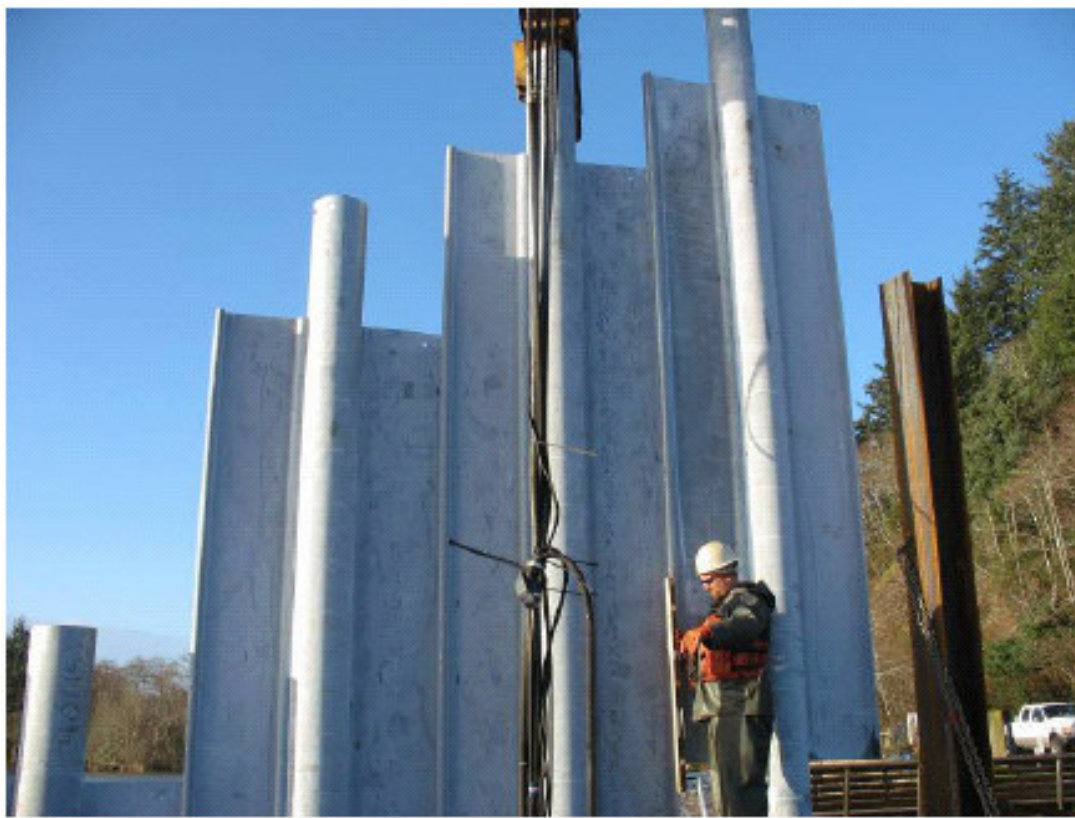
Figure 2: 12-inch diameter steel piles with interlocking 'wings' used to create the wave barrier (photo courtesy of Washington State Parks and Recreation, R. Johnson).

The piles were driven to replace the existing wood wave barrier. The five piles were monitored while being driven with different pile cap materials at different water depths at the facility. The pile cap materials used were wood (plywood), Conbest, Micarta, and Nylon (Figure 1). The Conbest material is not shown in Figure 1 but is similar to Micarta in size and thickness but looks like a layered aluminum disk in composition. The bubble curtain was tested with on/off cycles during each pile driving event. Figure 2 shows the piles with ‘wings’ and Figure 3 shows the locations of monitored piles.

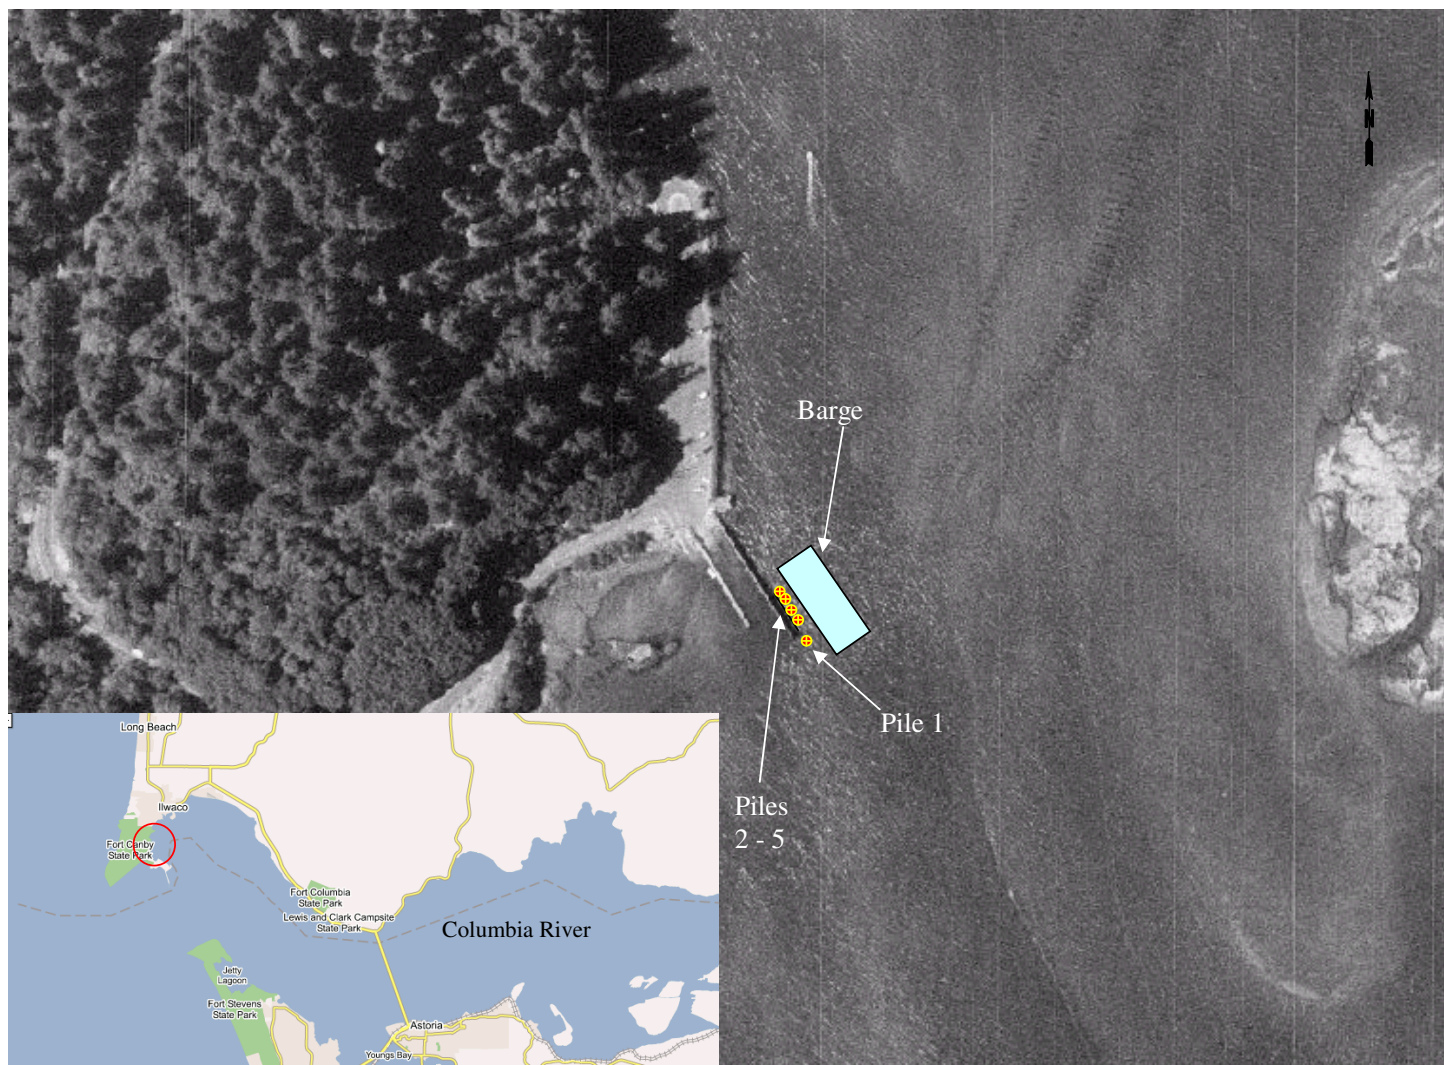
Figure 3: Location of underwater noise monitoring sites at the Cape Disappointment Wave Barrier project. Note: Piles are not to scale.

Located approximately 150 feet offshore at the farthest end of the new wave barrier (See Figure 1). The pile is located in 26 feet of water.

Piles 2 through 5 were driven while interlocked with three or more other piles starting approximately 10 feet inshore of pile 1. These piles ranged in depth between 16 and 12 feet of water dependent on tidal level.

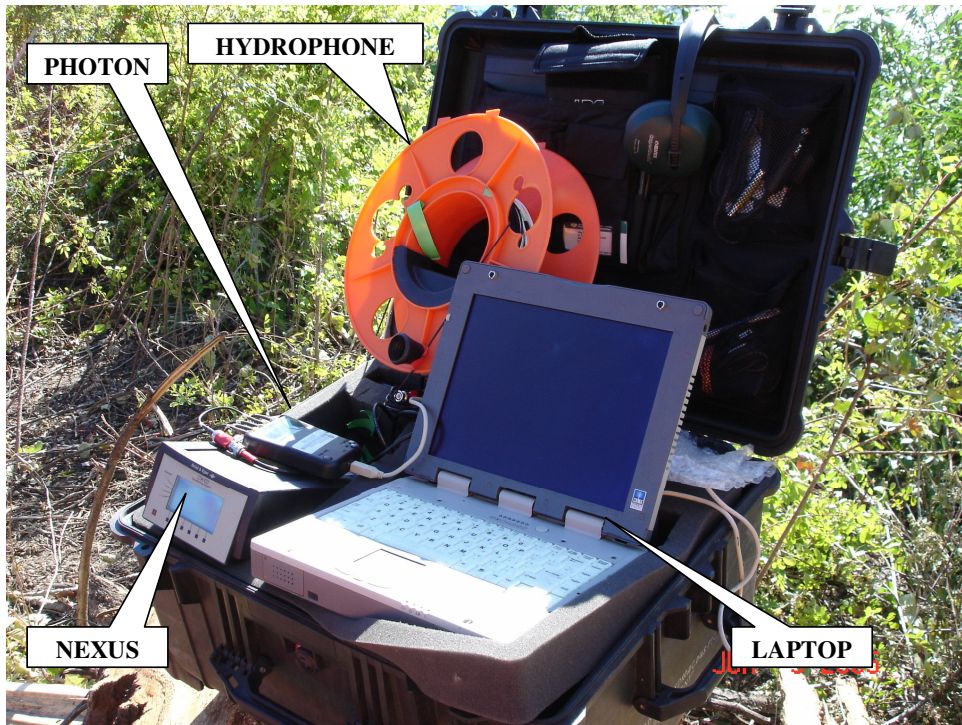
Figure 4: Underwater Sound Level Measurement Equipment

Underwater sound levels were measured using two Reson TC 4013 hydrophones. One hydrophone was positioned approximately at mid-water level. The second hydrophone was positioned approximately one foot from the bottom. The hydrophones were located at a distance of approximately 33 feet from the pile being monitored. The measurement system includes a Brüel and Kjær Nexus type 2692 4-channel signal conditioner, which kept the high underwater sound levels within the dynamic range of the signal analyzer (Figure 4). The output of the Nexus signal conditioner is received by a Dactron Photon 4-channel signal spectrum analyzer that is attached to an Itronix GoBook II laptop computer. The waveform of the pile strikes along with the number of strikes, overpressure minimum and maximum, absolute peak values, and RMS sound levels, integrated over 90% of the duration of the pulse, were captured and stored on the laptop hard drive for subsequent signal analysis. The system and software calibration is checked annually against a NIST traceable standard. The operation of the hydrophone was checked in the field using a GRAS type 42AC high-level pistonphone with a hydrophone adaptor. The pistonphone signal was 146 dB re: 1 μ Pa. The pistonphone signal levels produced by the pistonphone and measured by the measurement system were within 1 dB and the operation of the system was judged acceptable over the study period. A photograph of the system and its components are shown in Figure 4.

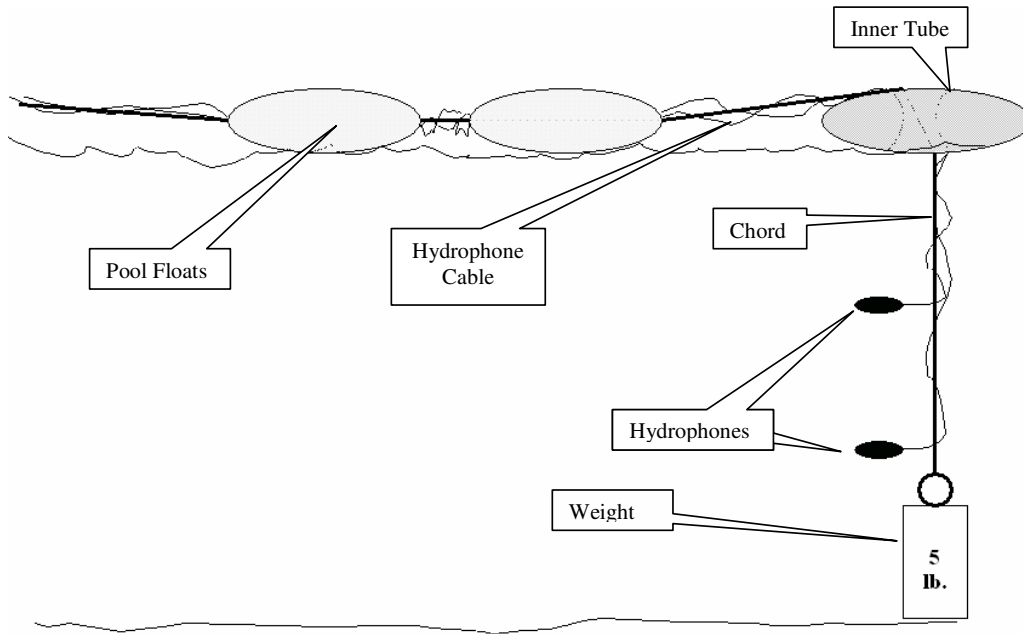
Figure 5: Diagram of hydrophone deployment.

The location of the hydrophones is determined by allowing a clear line of sight between the pile and the hydrophone, with no other structures nearby. The distance from the pile to the hydrophone location was measured using a Bushnell Yardage Pro rangefinder. The hydrophone was attached to a weighted nylon cord anchored with a five-pound weight. The cord and hydrophone cables were attached to surface floats that kept the hydrophones at the proper location in the water column (Figure 5). For pile 1, the hydrophones were in a location with no other obstructions near it. For piles 2 through 5, the hydrophones were located between the pile and the barge.

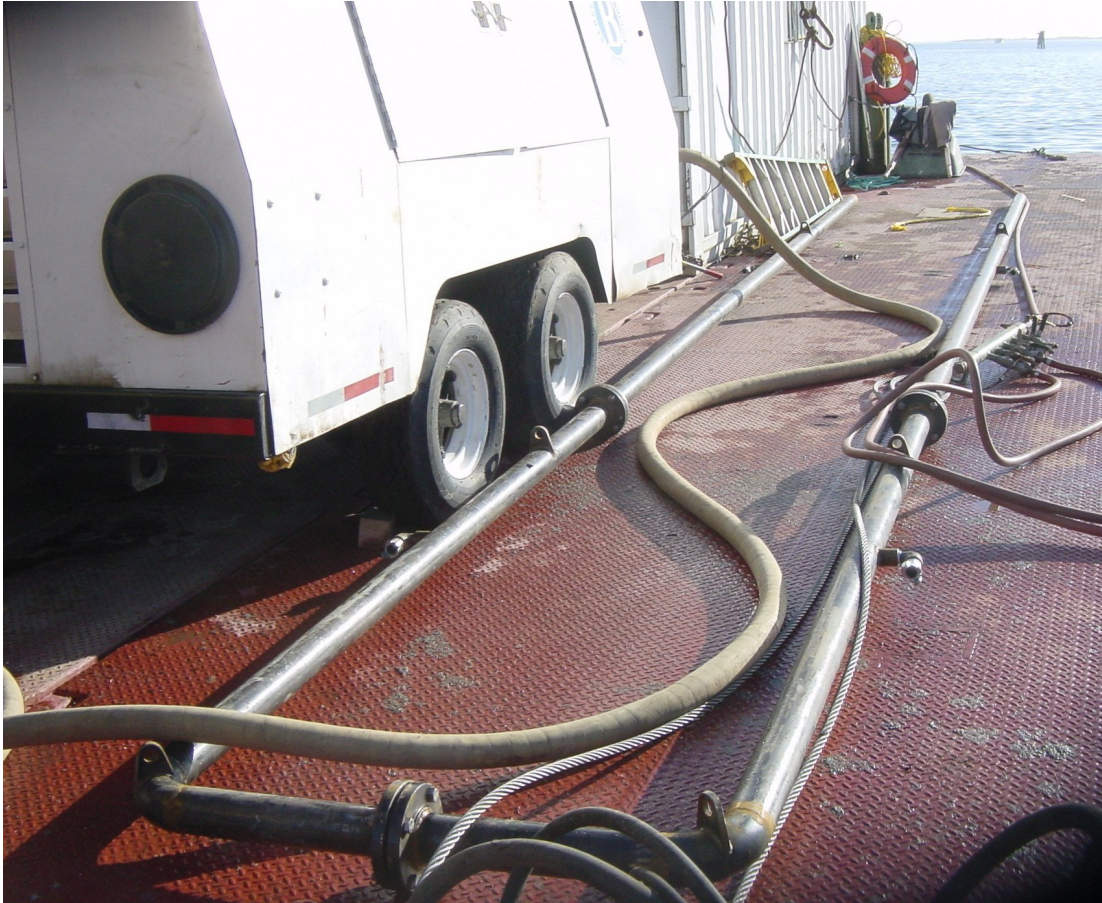
Figure 6: “U” shaped bubble curtain for use on wave barrier piles.

Two bubble curtain designs were used by the contractor at the Cape Disappointment Boat Launch facility. The first was a standard single ring placed at the bottom of pile 1 based on the design of Longmuir and Lively (2001). The second bubble curtain was a “U” shaped design that enabled the curtain to be fitted around the base of several piles that were interlocked together in a wall design (Figure 6).

It is important to note that during the use of the “U” shaped bubble curtain on piles 2 through 5 the tidal current swept some of the bubble curtain away from the pile being driven. This happened after high tide as water began to recede rapidly. However, as can be seen in the analysis that follows it had little or no impact on the effectiveness of the bubble curtain.

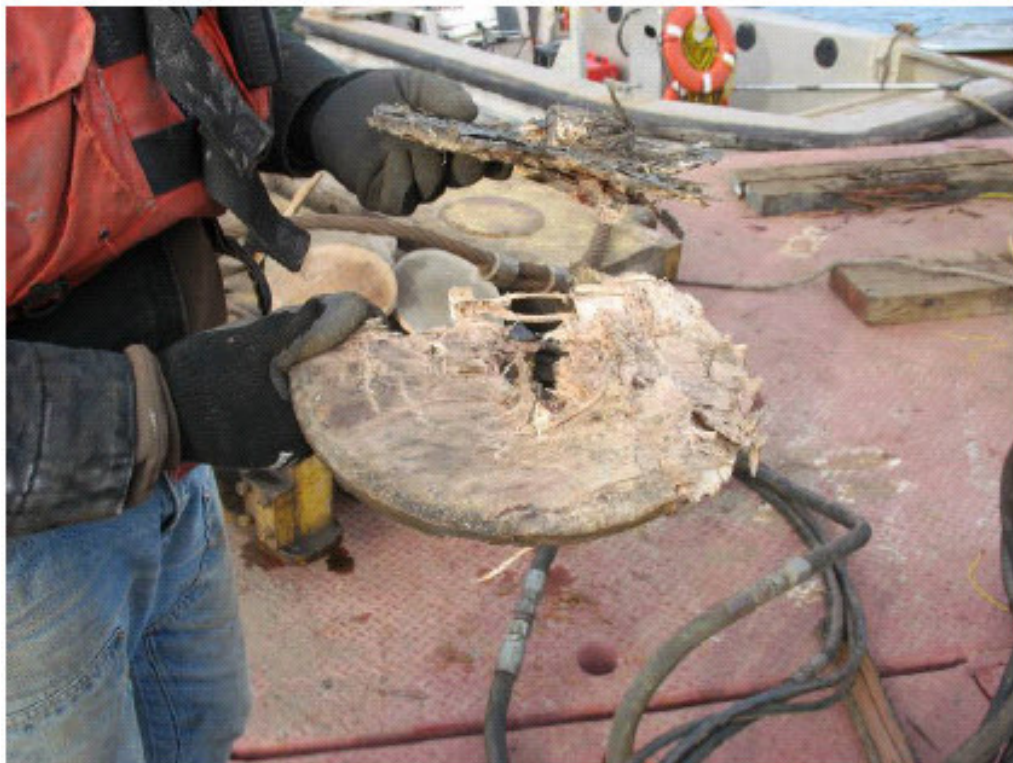
Figure 7: Fractured and compressed wood pile cap after being used on piles 5, 6, and 7 (photo courtesy of Washington State Parks and Recreation, R. Johnson)

The highest absolute peak from the midwater and bottom hydrophones is 181 dB_{peak} for wood. The highest midwater RMS was 170 dB_{RMS} and bottom RMS was 169 dB_{RMS}. The highest midwater and bottom SEL for the peak strike were both 157 dB_{SEL}. Rise times for the wood pile cap were quite long indicating a substantial reduction of the transfer of energy from the hammer. Figure 7 shows a wood pile cap that has been compressed and shattered after use on only three piles.

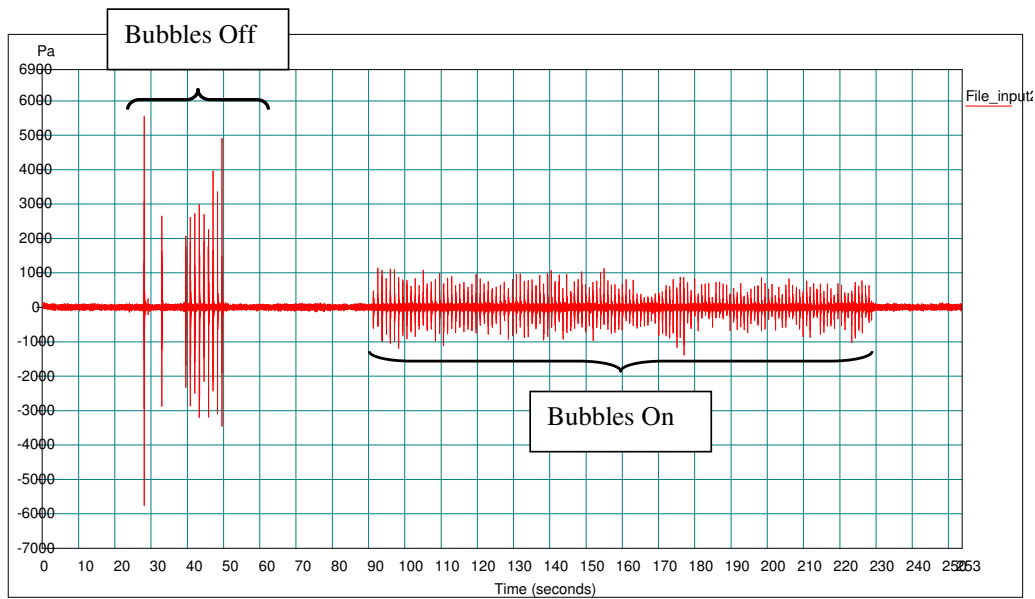
Figure 8: Waveform recording indicating the effects on amplitude with bubble curtain on versus bubble curtain off for pile 3.

The average peak sound reductions achieved with the bubble curtain ranged between 7 and 11 dB. This can be seen visually in Figure 8. This indicates that the bubble curtain was functioning slightly better than anticipated.

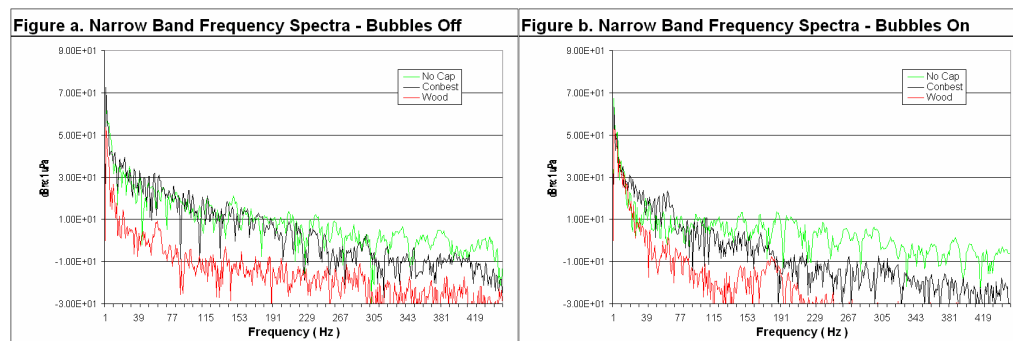
Figure 9: Spectral Frequency Analysis comparing Conbest and wood pile caps versus no caps with bubble curtain on and off.

A spectral frequency analysis was conducted on the peak pile strike (Figures 9 and 10). Figure 9 indicates that for the single pile the wood pile cap as having the greatest effect of lowering the sound levels of all frequencies even with the bubble curtain off. The Conbest pile cap was able to reduce only the higher frequencies above approximately 600 Hz with the bubble curtain off. With the bubble curtain on the frequencies for Conbest were lowered from

approximately 190 Hz and above. With no pile cap there was little change in frequency levels with or without the bubble curtain.

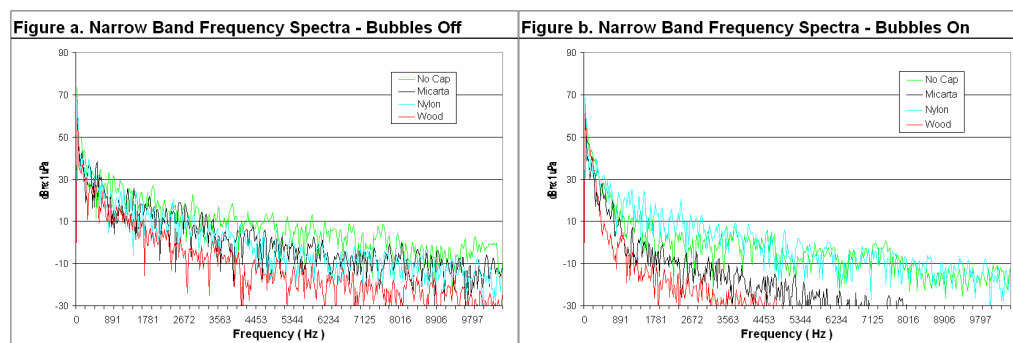
Figure 10: Spectral Frequency Analysis comparing Micarta, Nylon, and wood pile caps versus no caps with bubble curtain on and off.

Figure 10 indicates that for the piles with ‘wings’ when the bubble curtain is off the wood pile cap was able to reduce frequency levels at all frequencies. Nylon and Micarta were able to reduce frequencies above approximately 600 Hz, similarly to Conbest above. When the bubble curtain was turned on the performance of the wood and Micarta pile caps were enhanced whereas only a slight improvement was observed for Nylon. Micarta is able to reduce frequencies above approximately 450 Hz with the bubble curtain on. Nylon actually exhibited sound levels higher than with no cap at frequencies between approximately 900 and 3500 Hz and then no difference when compared to no cap with all other frequencies.

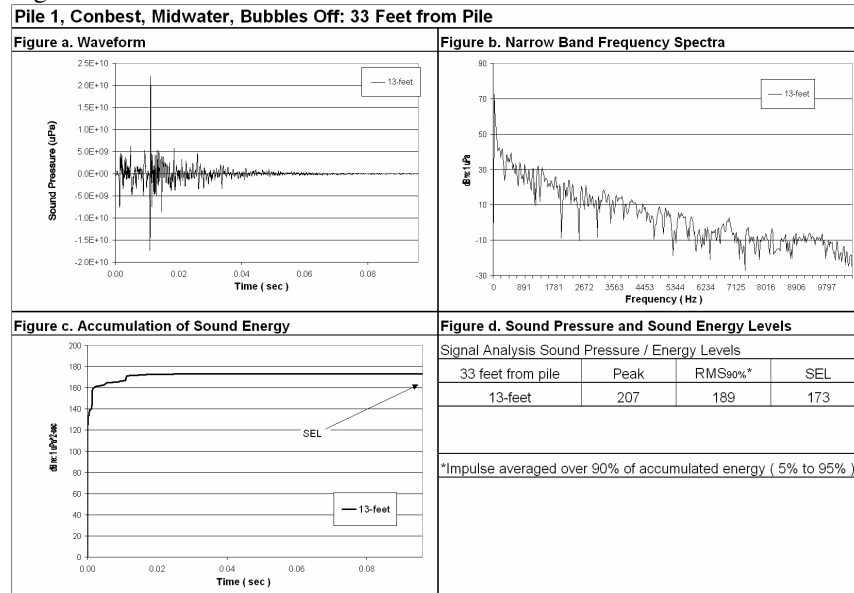
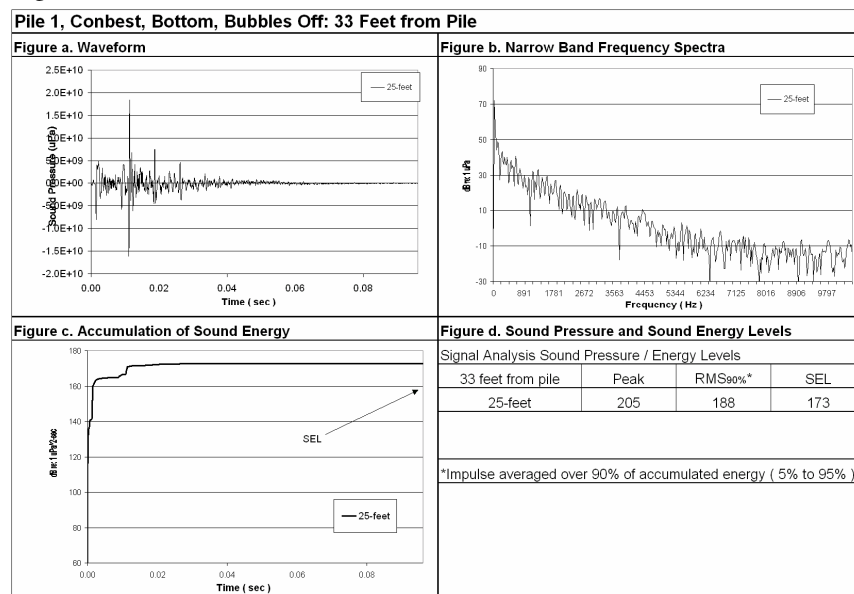
Figure 12: Waveform Analysis of Pile 1 Sound Pressure Levels with Conbest pile cap and Bubble Curtain Off, Midwater and Bottom.

The highest absolute peak from the midwater hydrophone is 207 dB_{peak} and the absolute highest peak from the bottom hydrophone is 206 dB_{peak} for Conbest. The highest midwater and bottom RMS were both 189 dB_{RMS} and 188 dB_{RMS} respectively. The highest midwater and bottom SEL for the peak strike were both 173 dB_{SEL}. Rise time for the Conbest pile cap was relatively long indicating a reduction of the transfer of energy from the hammer. Virtually all of the peak values exceed 180 dB_{peak} and the RMS values exceeded 150 dB_{RMS} for both the midwater and bottom hydrophones.

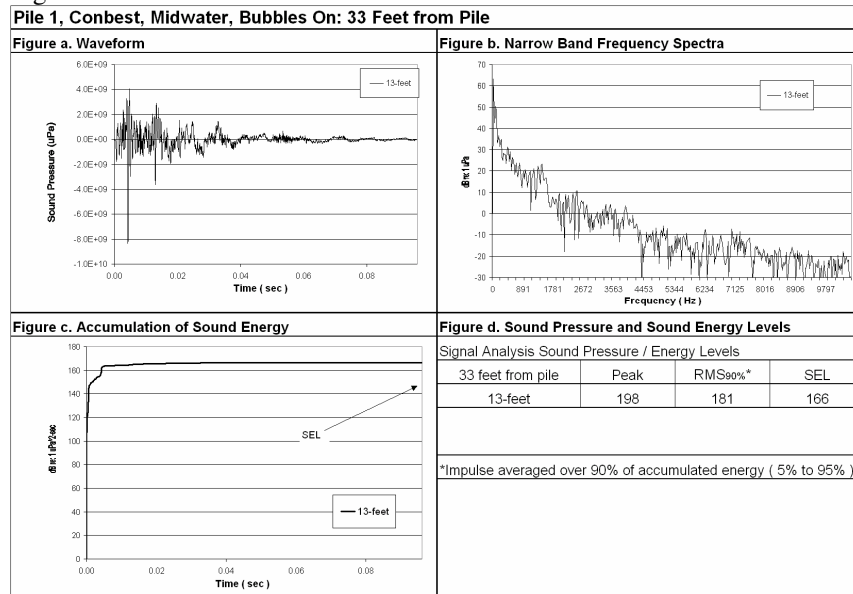
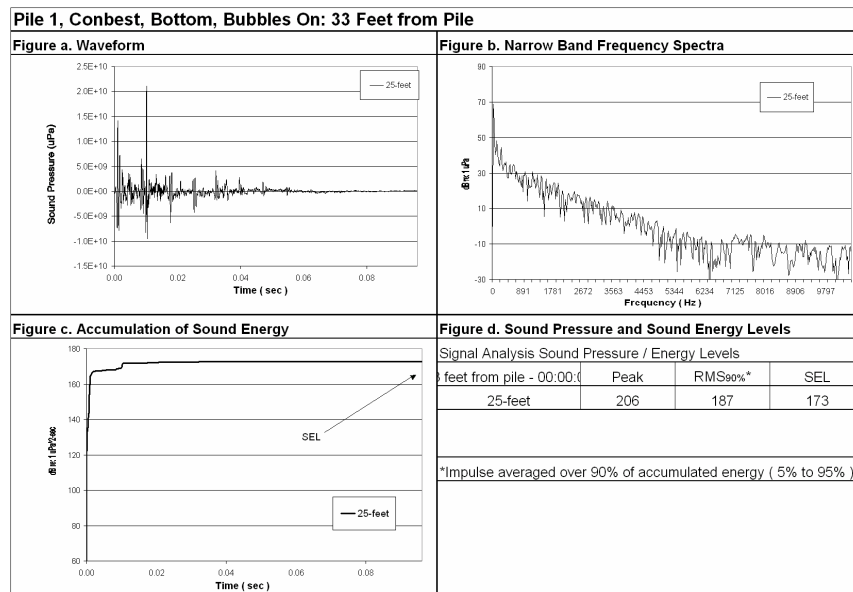
Figure 13: Waveform Analysis of Pile 1 Sound Pressure Levels with Conbest Pile Cap and Bubble Curtain On, Midwater and Bottom.

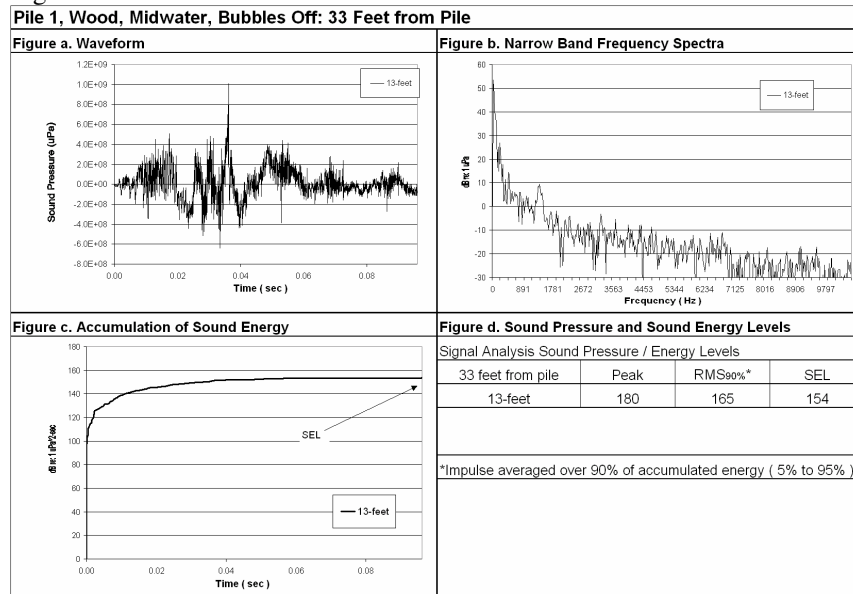
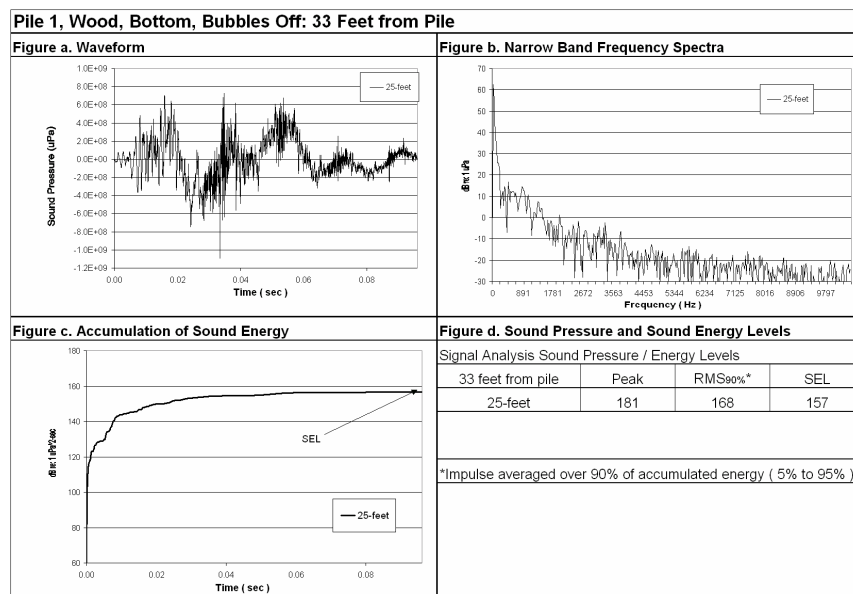
Figure 14: Waveform Analysis of Pile 1 Sound Pressure Levels with Wood Pile Cap and Bubble Curtain Off, Midwater and Bottom.

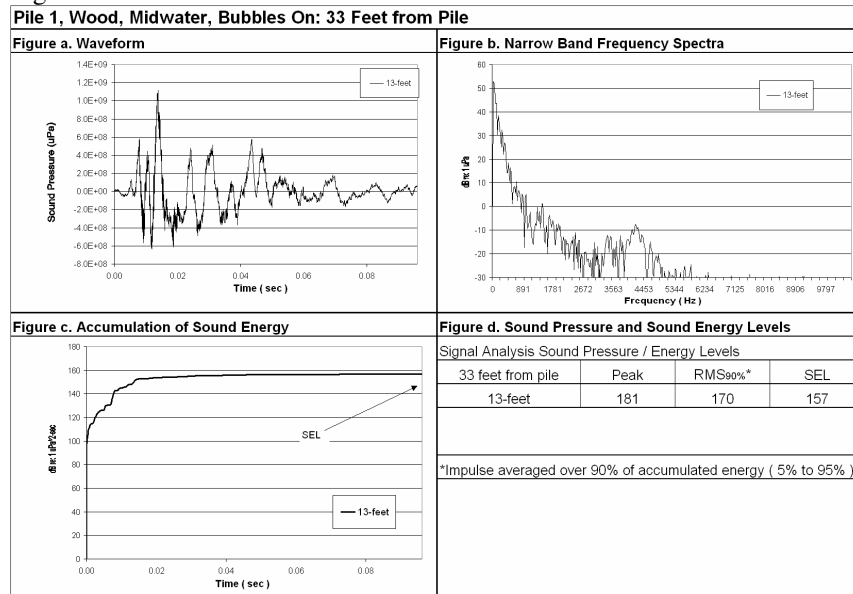
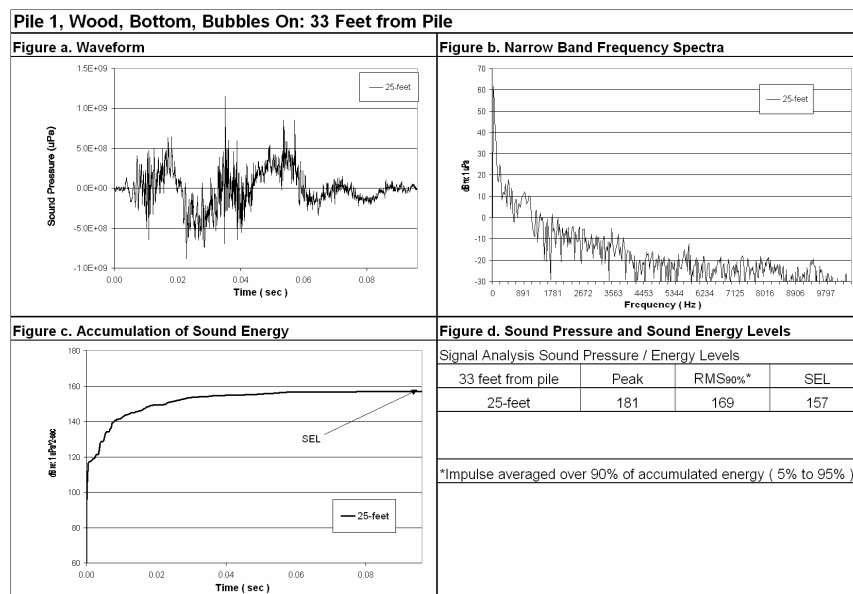
Figure 15: Waveform Analysis of Pile 1 Sound Pressure Levels with Wood Pile Cap and Bubble Curtain On, Midwater and Bottom.

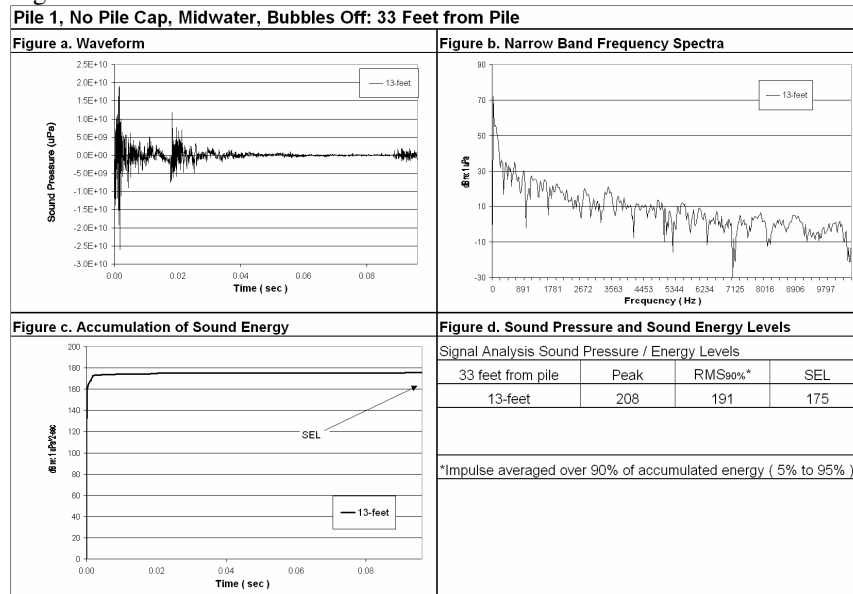
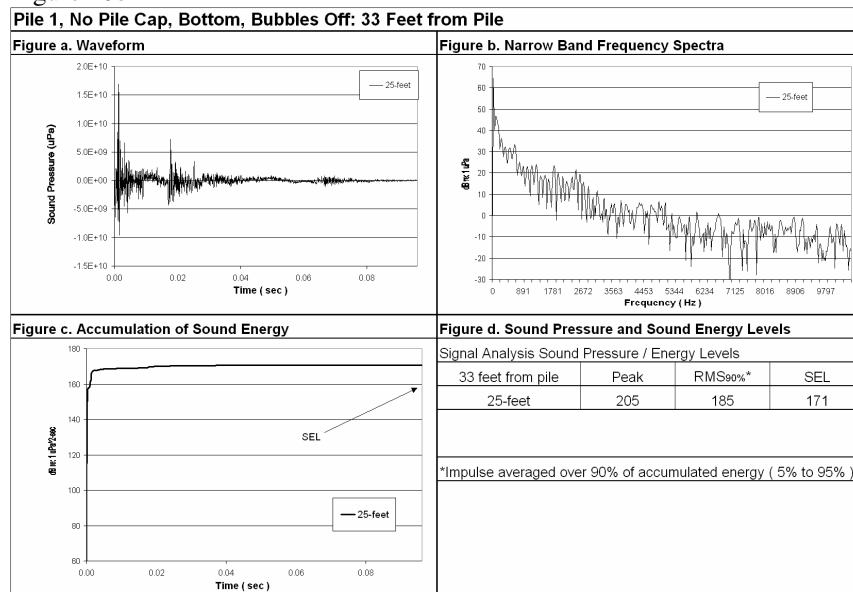
Figure 16: Waveform Analysis of Pile 1 Sound Pressure Levels with No Pile Cap and Bubble Curtain Off, Midwater and Bottom.

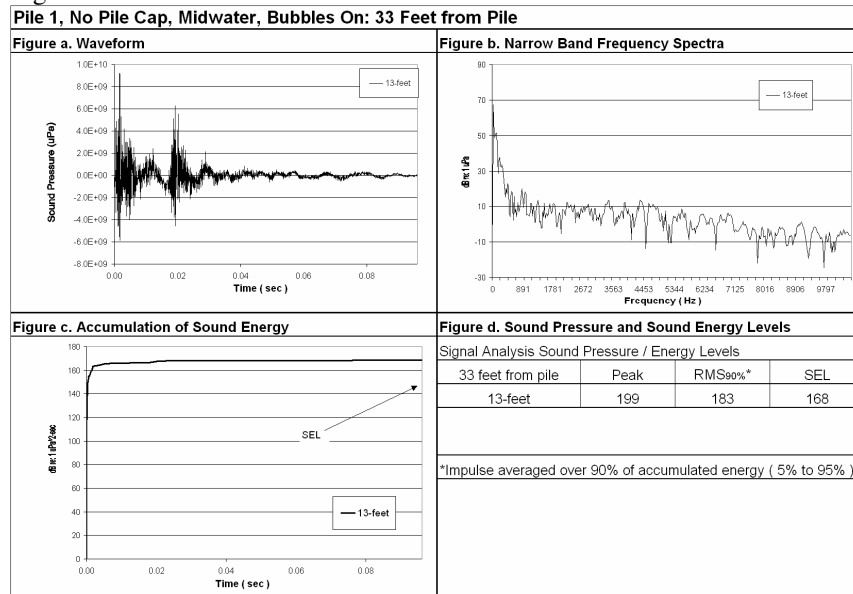
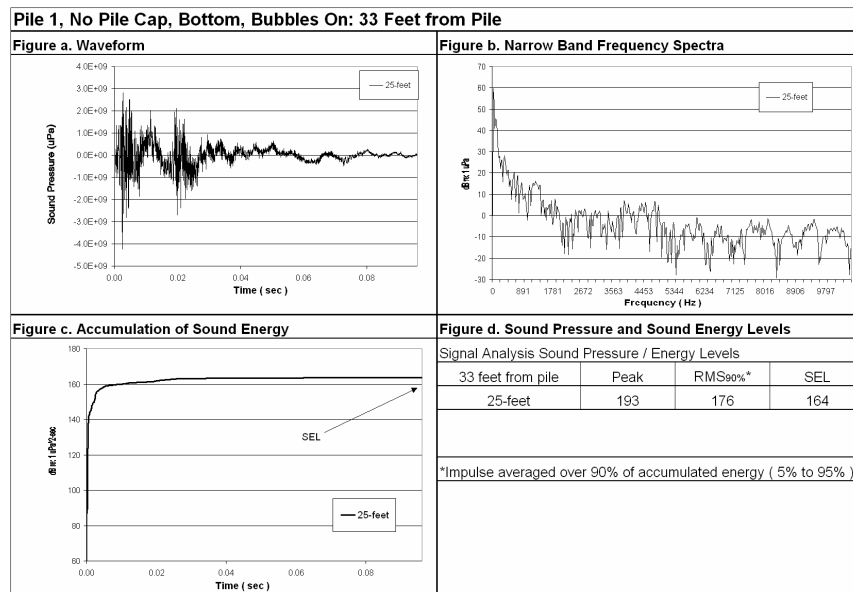
Figure 17: Waveform Analysis of Pile 1 Sound Pressure Levels with No Pile Cap and Bubble Curtain On, Midwater and Bottom.

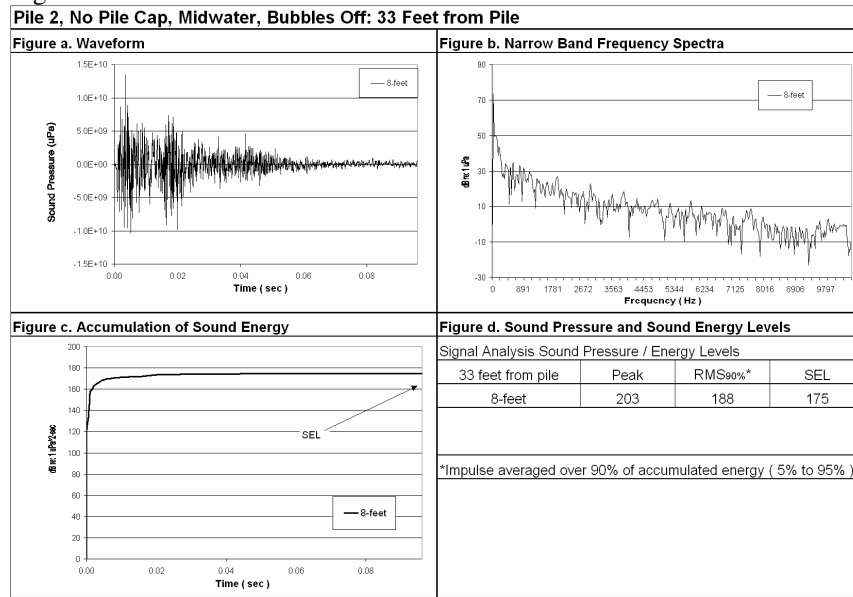
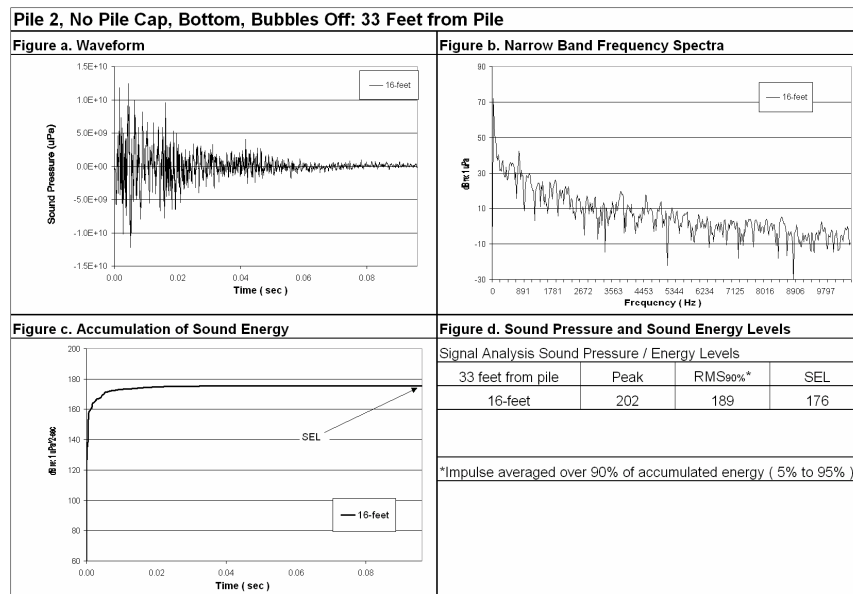
Figure 18: Waveform Analysis of Pile 2 Sound Pressure Levels with No Pile Cap and Bubble Curtain Final Off, Midwater and Bottom.

The highest absolute peak from the midwater hydrophone is 203 dB_{peak} and the absolute highest peak from the bottom hydrophone is 202 dB_{peak}. The highest midwater RMS was 188 dB_{RMS} and bottom RMS was both 189 dB_{RMS} respectively. The highest midwater SEL was 175 dB_{SEL} and bottom SEL was 176 dB_{SEL} for the peak strikes. Rise times with no pile cap were relatively short with the bubble curtain turned off but then lengthened when the bubbles were turned on. 137 peak pile strike (71%) values exceeded 180 dB_{peak} for the midwater and bottom hydrophones with the bubble curtain on. Virtually all the RMS values exceeded 150 dB_{RMS} for both the midwater and bottom hydrophones.

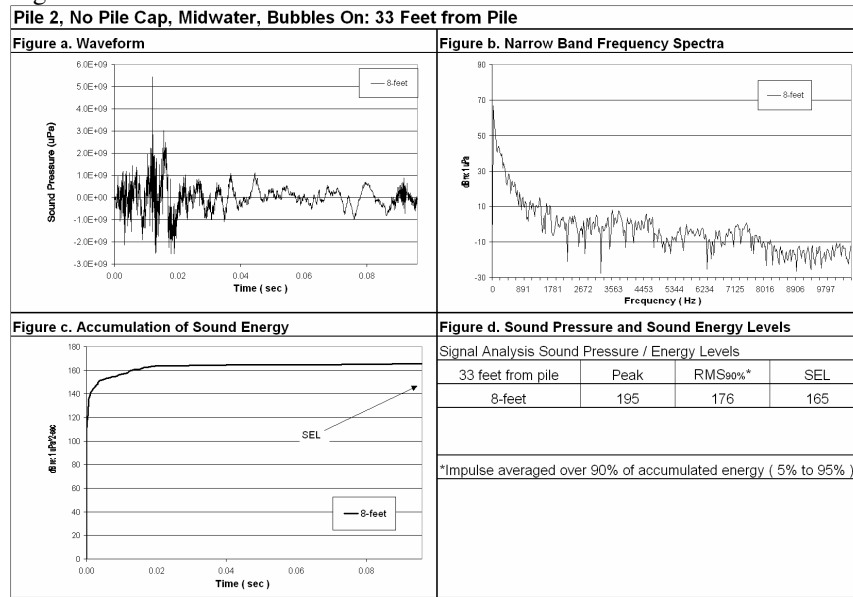
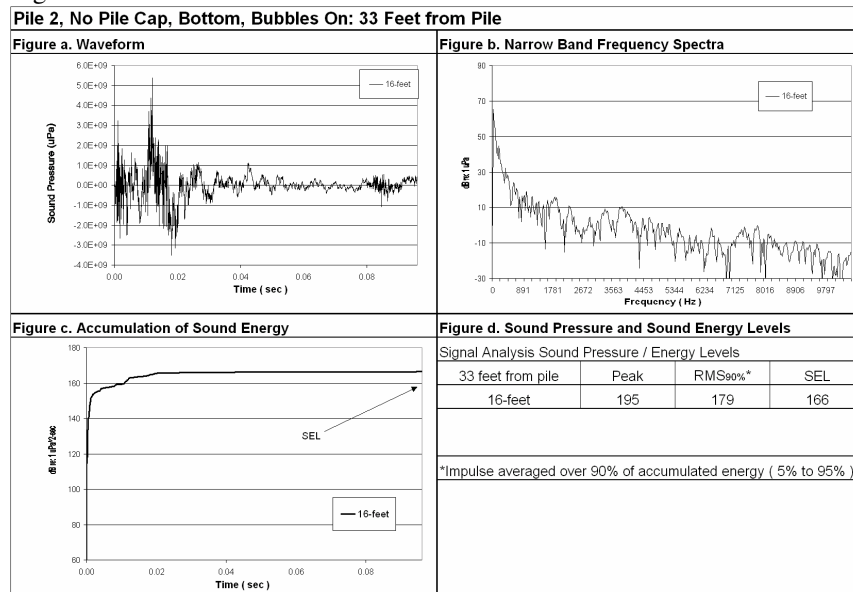
Figure 19: Waveform Analysis of Pile Number 2 Sound Pressure Levels with No Pile Cap and Bubble Curtain On, Midwater and Bottom.

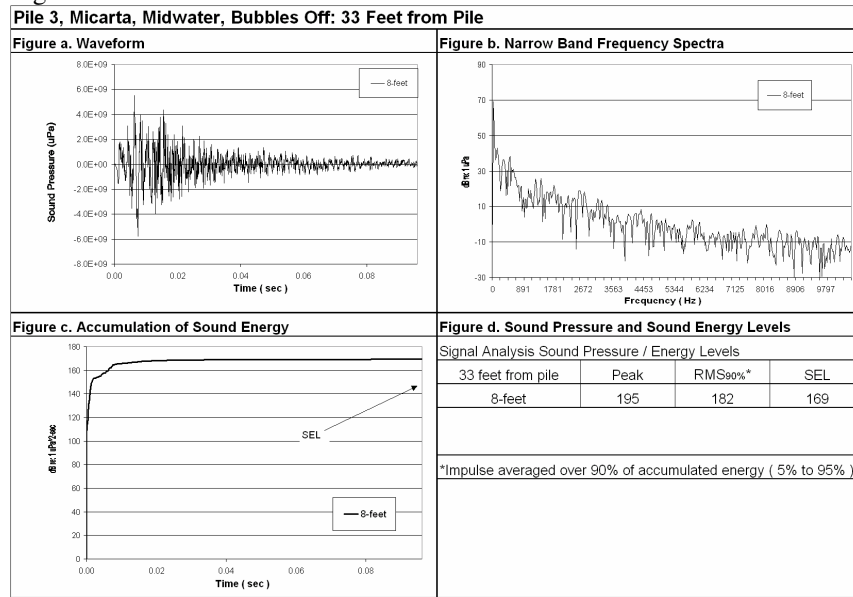
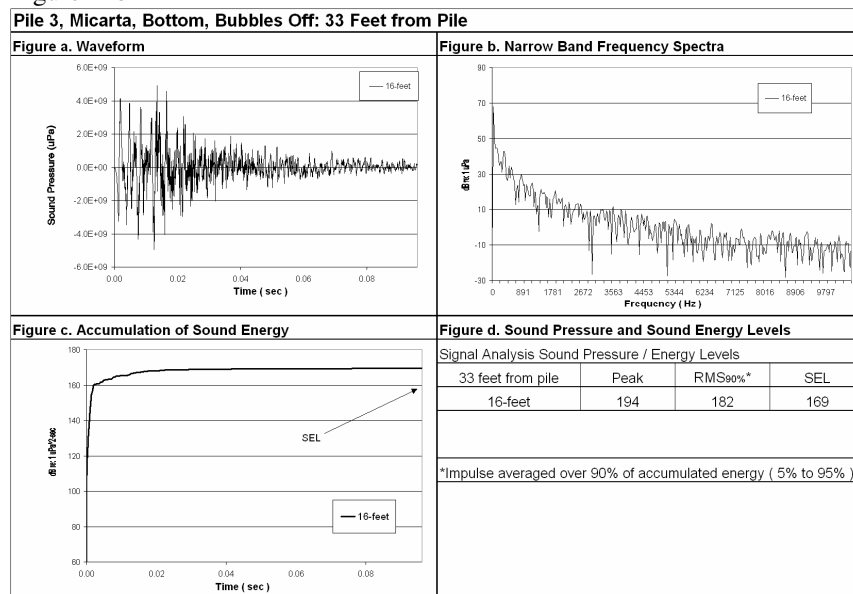
Figure 20: Waveform Analysis of Pile Number 3 Sound Pressure Levels with Micarta Pile Cap and Bubble Curtain Off, Midwater and Bottom.

The highest absolute peak from the midwater hydrophone is 195 dB_{peak} and the absolute highest peak from the bottom hydrophone is 194 dB_{peak} for Micarta. The highest midwater and bottom RMS were both 189 dB_{RMS} and 188 dB_{RMS} respectively. The highest midwater and bottom SEL for the peak strike were both 169 dB_{SEL}. Rise time for the Micarta pile cap is relatively long indicating a reduction of the transfer of energy from the hammer. The highest midwater SEL for the peak strike was 178 dB_{SEL} and 180 dB_{SEL} for the bottom. Only 55 midwater pile strike peak values (37%) exceeded 180 dB_{peak} with the bubble curtain on. All but five bottom pile strike peak values exceeded 180 dB_{peak}. Virtually all pile strike RMS values exceeded 150 dB_{RMS} for both the midwater and bottom hydrophones.

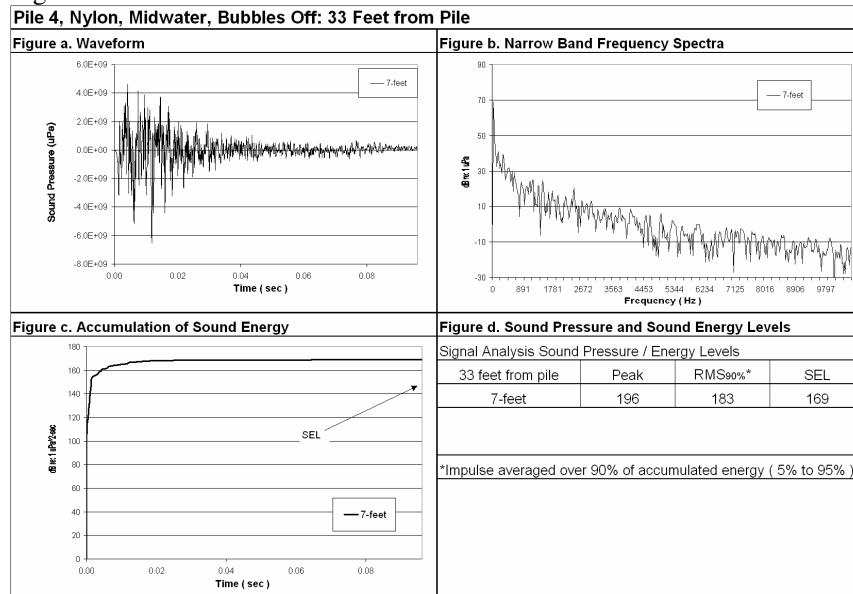
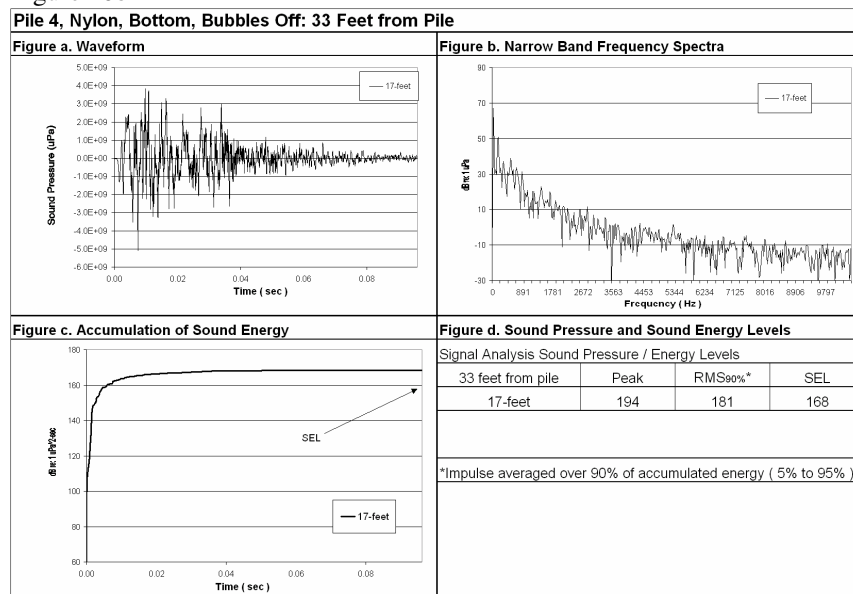
Figure 22: Waveform Analysis of Pile Number 4 Sound Pressure Levels with Nylon Pile Cap and Bubble Curtain Off, Midwater and Bottom.

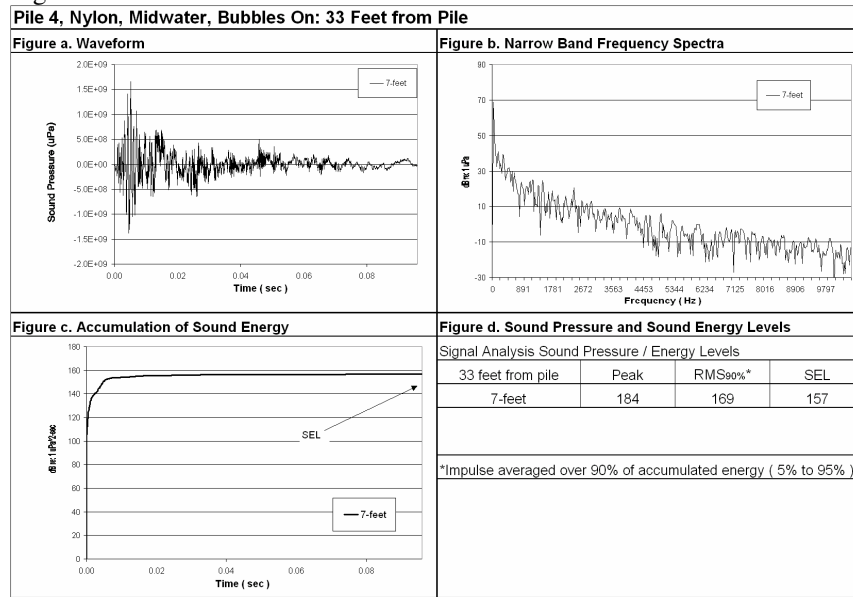
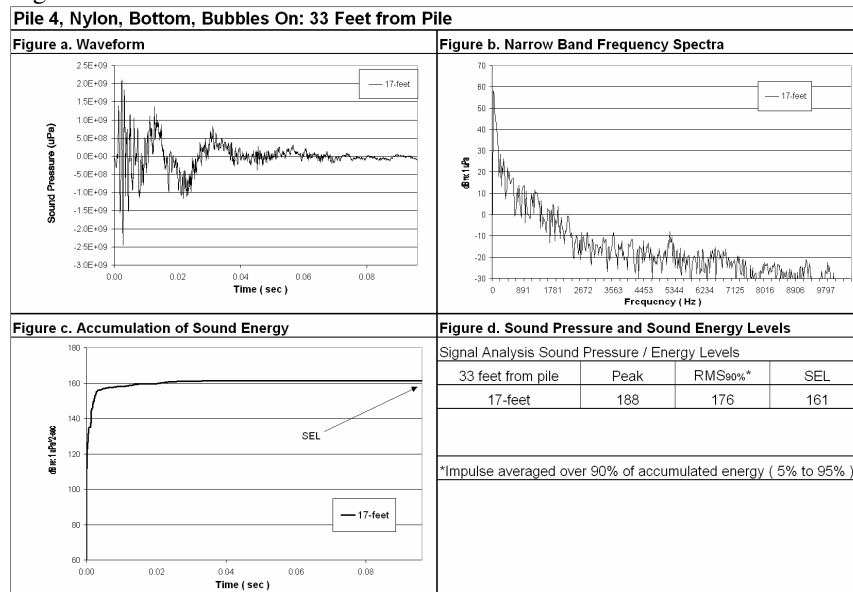
Figure 23: Waveform Analysis of Pile Number 4 Sound Pressure Levels with Nylon Pile Cap and Bubble Curtain On, Midwater and Bottom.

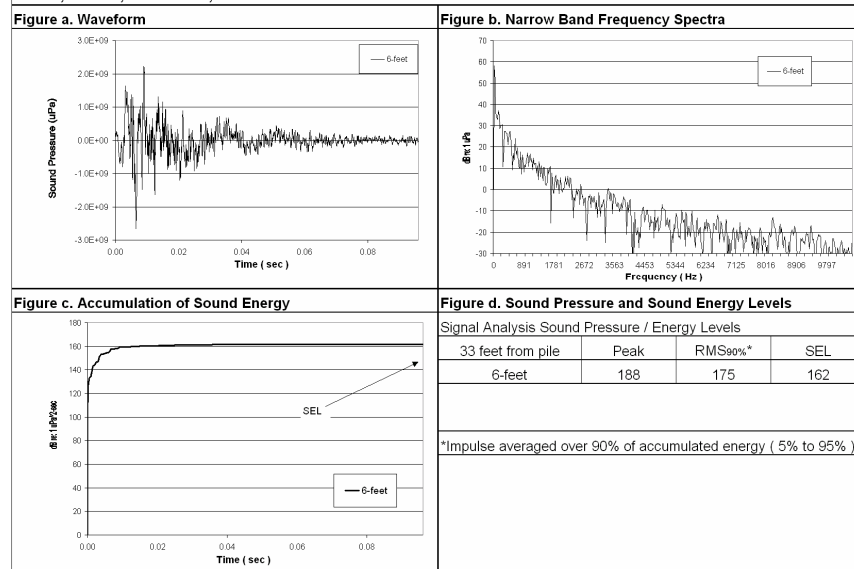
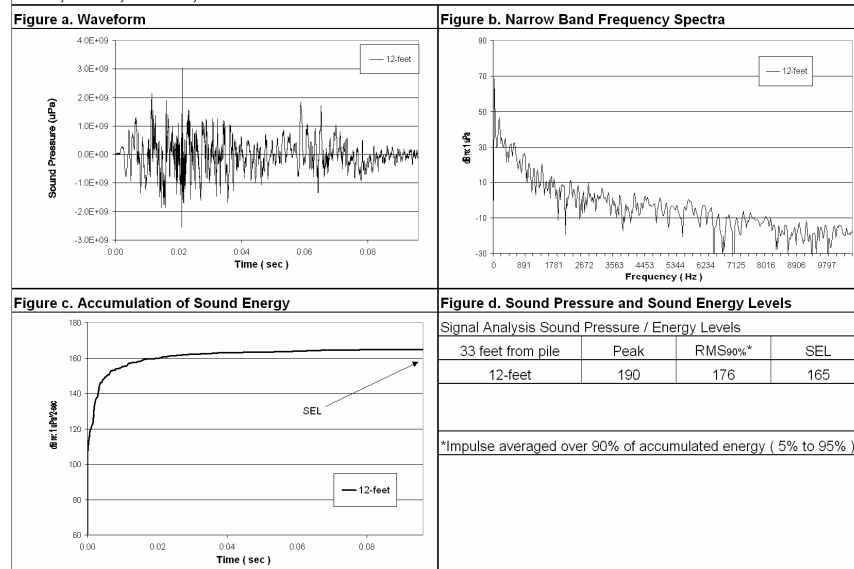
Pile 5, Wood, Midwater, Bubbles Off: 33 Feet from Pile

Pile 5, Wood, Bottom, Bubbles Off: 33 Feet from Pile

Figure 24: Waveform Analysis of Pile Number 5 Sound Pressure Levels with Wood Pile Cap and Bubble Curtain Off, Midwater and Bottom.
