**UNDERWATER SOUND LEVELS
ASSOCIATED WITH PILE DRIVING AT
THE CAPE DISAPPOINTMENT BOAT
LAUNCH FACILITY, WAVE BARRIER
PROJECT**

*Prepared by:
Jim Laughlin
Washington State Department of
Transportation
Office of Air Quality and Noise
15700 Dayton Avenue North,
P.O. Box 330310
Seattle, WA 98133-9710*

March 2006

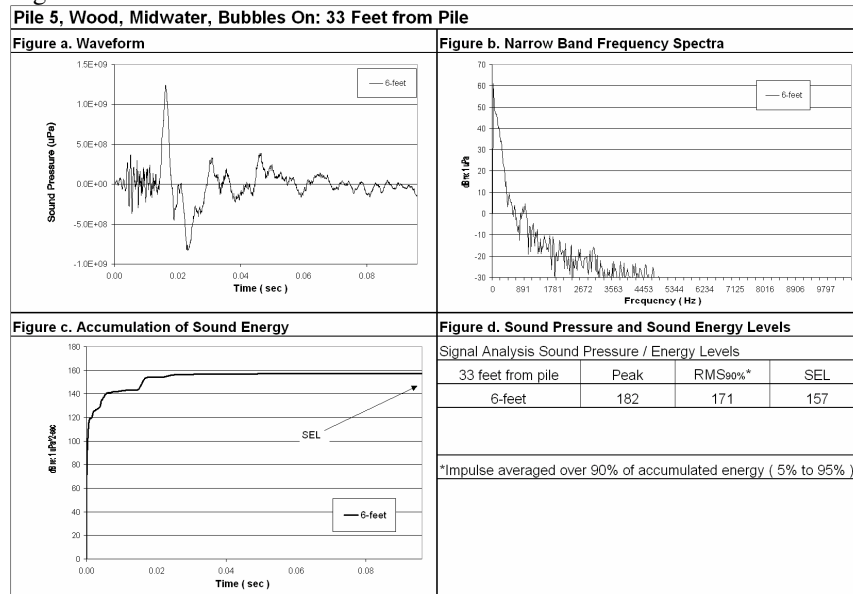
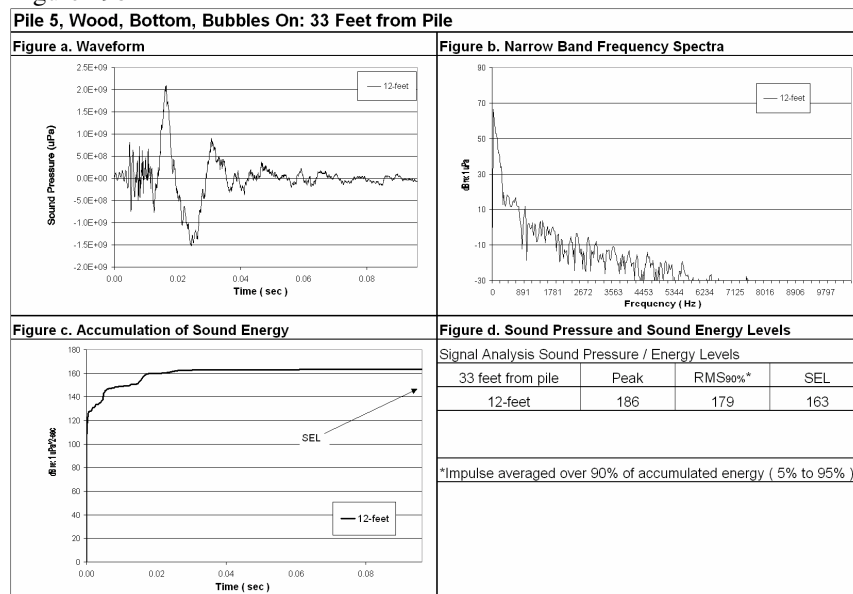
Figure 25: Waveform Analysis of Pile Number 5 Sound Pressure Levels with Wood Pile Cap and Bubble Curtain On, Midwater and Bottom.
